# **INDOOR AIR QUALITY ASSESSMENT**

**Johnny Appleseed Elementary School  
845 Main Street  
Leominster, MA 01453**

Prepared by:  
Massachusetts Department of Public Health  
Center for Environmental Health  
Emergency Response/Indoor Air Quality Program  
October 2005

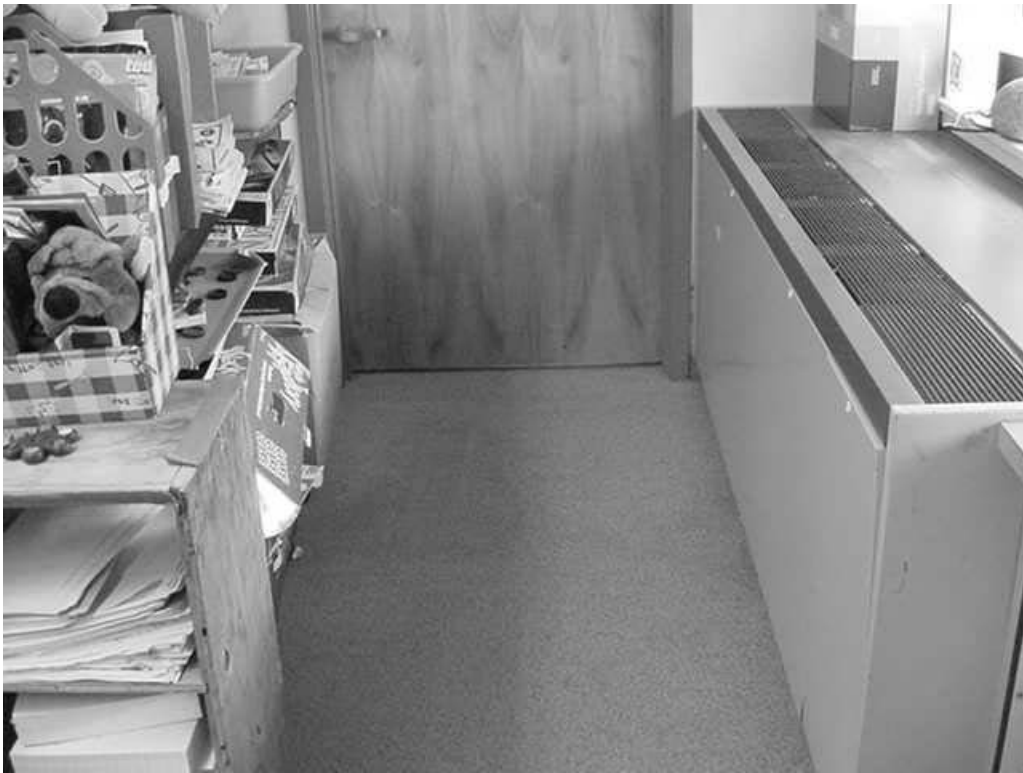
Picture 1

Fresh air in classrooms is mechanically provided by unit ventilator (univent) systems equipped with high efficiency pleated filters (Pictures 1 and 2). A univent draws air from the outdoors through a fresh air intake located on the exterior wall of the building (Picture 3) and returns air through an air intake located at the base of the unit ([Figure 1](#)). Fresh and return air are mixed, filtered, heated and provided to classrooms through an air diffuser located in the top of the unit. Univents were operating at the time of the assessment. Obstructions to airflow, such as desks and other items located on or in front of univents, were observed in some classrooms

Classroom Univent

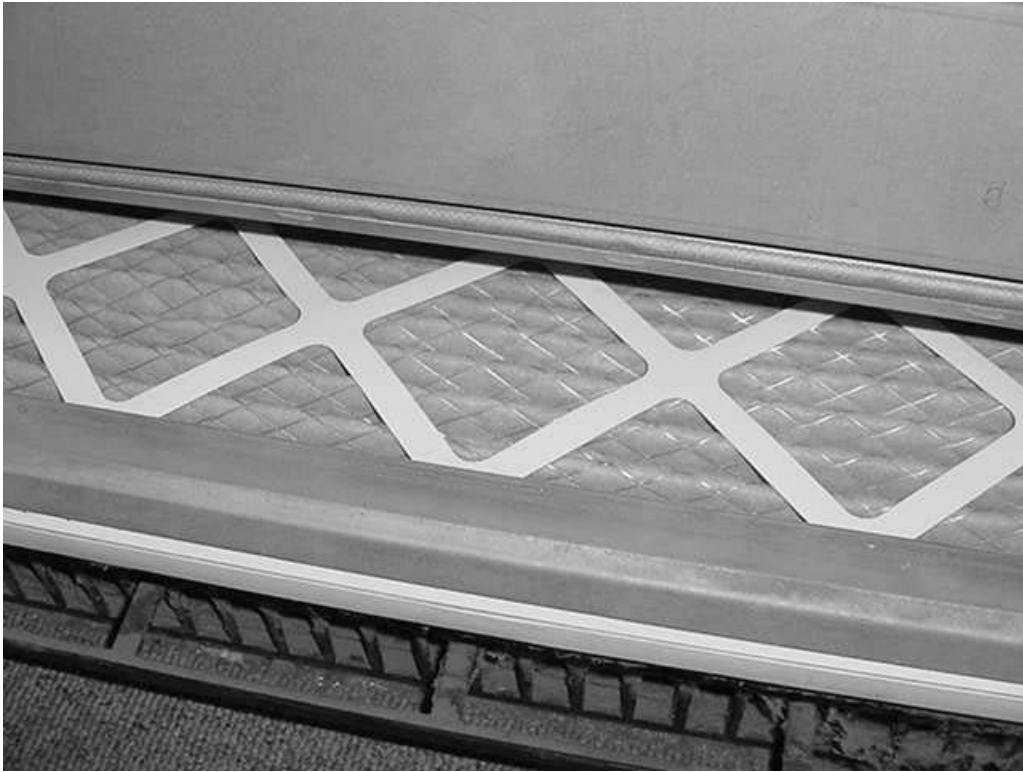
Picture 2

High Efficiency Pleated Air Filter in Univent

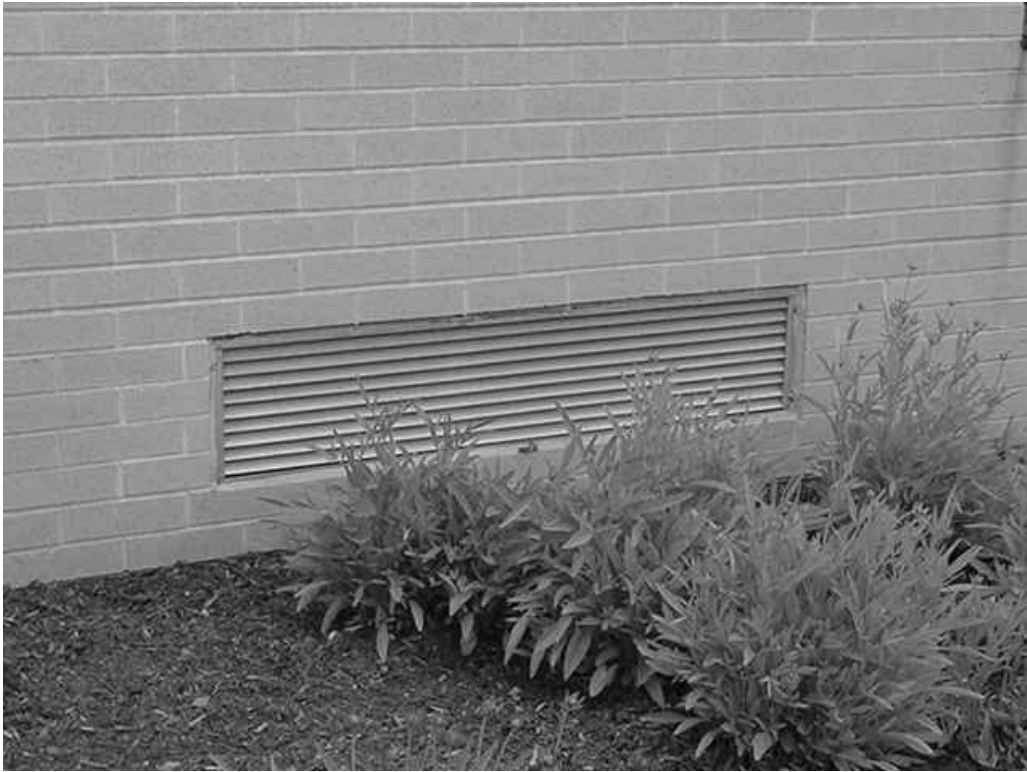
Picture 3

Univent Fresh Air intake, Note Proximity of Plants/Shrubbery

11. Remove plants growing against the building and its foundation to prevent water intrusion through brickwork.
12. Clear plant growth and other materials/debris away from the proximity of univent air intakes.

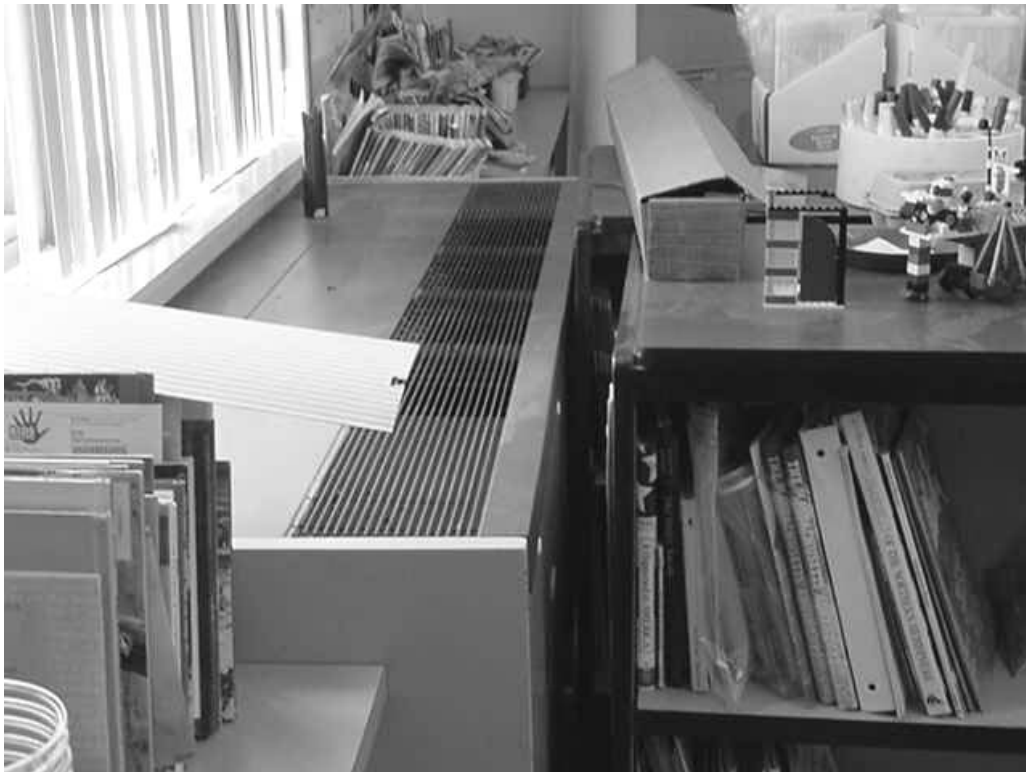
Picture 4

(Picture 4). To function as designed, univents must be allowed to operate and remain free of obstructions.

Univent Return Vent (Bottom Front) Obstructed by Furniture in Classroom

4. Remove all obstructions from univents and exhaust vents to facilitate airflow. Close classroom doors to improve air exchange.
5. Remove debris and dust accumulated on ventilation grilles and fan blades.

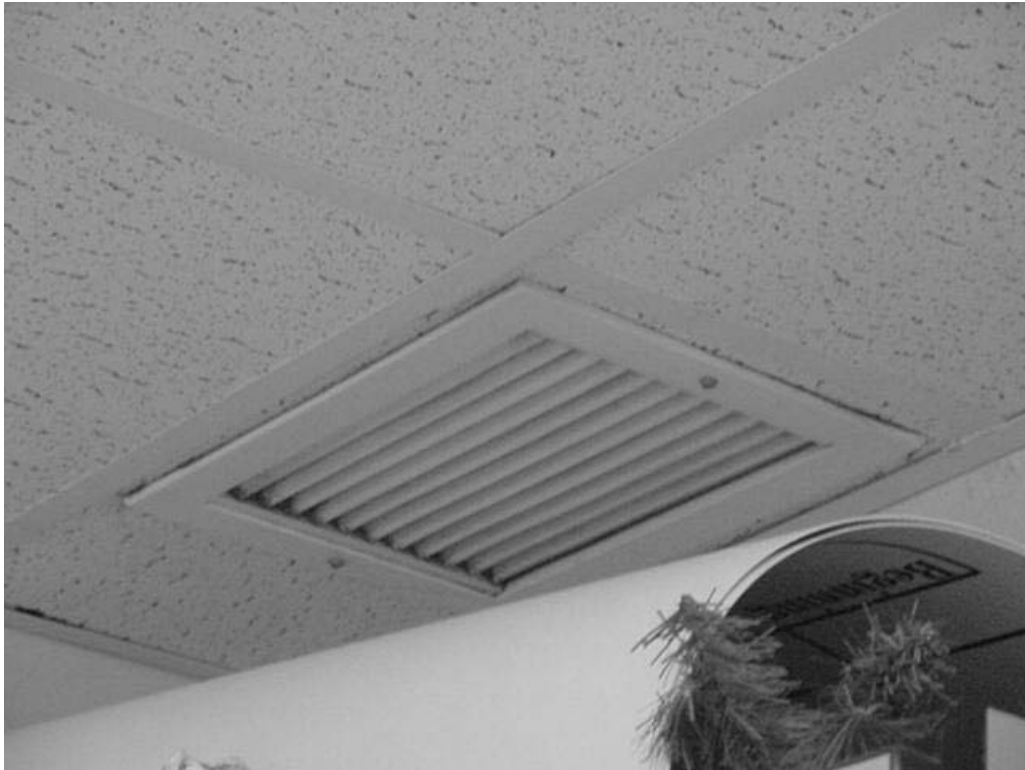
Picture 5

Exhaust ventilation is provided by ceiling- or closet-mounted exhaust vents (Pictures 5 and 6), which are ducted to motorized fan units. For rooms with closet exhausts, classroom air is drawn through a space beneath the closet door, into the closet (Picture 7), and out the vent in the ceiling of the closet. Some doors were undercut insufficiently (less than 1 inch); therefore, draw of air into the closet would be difficult. Closet exhaust vents are also prone to obstruction by items placed in front of floor level openings and/or on shelves below the vent (Picture 8). Some closet exhaust vents were off, drawing weakly and/or backdrafting in some classrooms (Table 1). As with the univents, exhaust vents must be allowed to operate and remain free of obstructions. Some ceiling-mounted exhaust vents were located near hallway doors (Picture 9); the location of these exhausts can result in limited exhaust efficiency. When classroom doors are open, exhaust vents will tend to draw air from both the hallway and the classroom, reducing the effectiveness of the exhaust vent to remove common environmental pollutants.

Ceiling-Mounted Exhaust Vent

1. Examine exhaust vents for function and make repairs as necessary.
2. Examine undercut closet doors and, where necessary, increase space between door and floor.

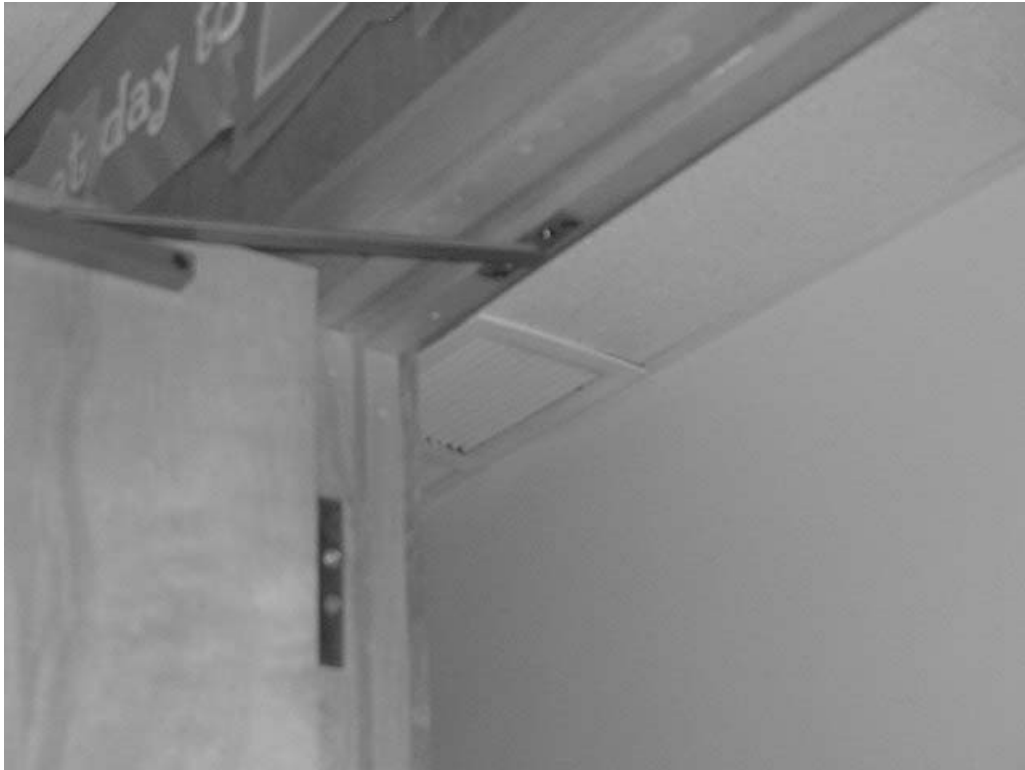
Picture 6

Coat Closet Exhaust Vent

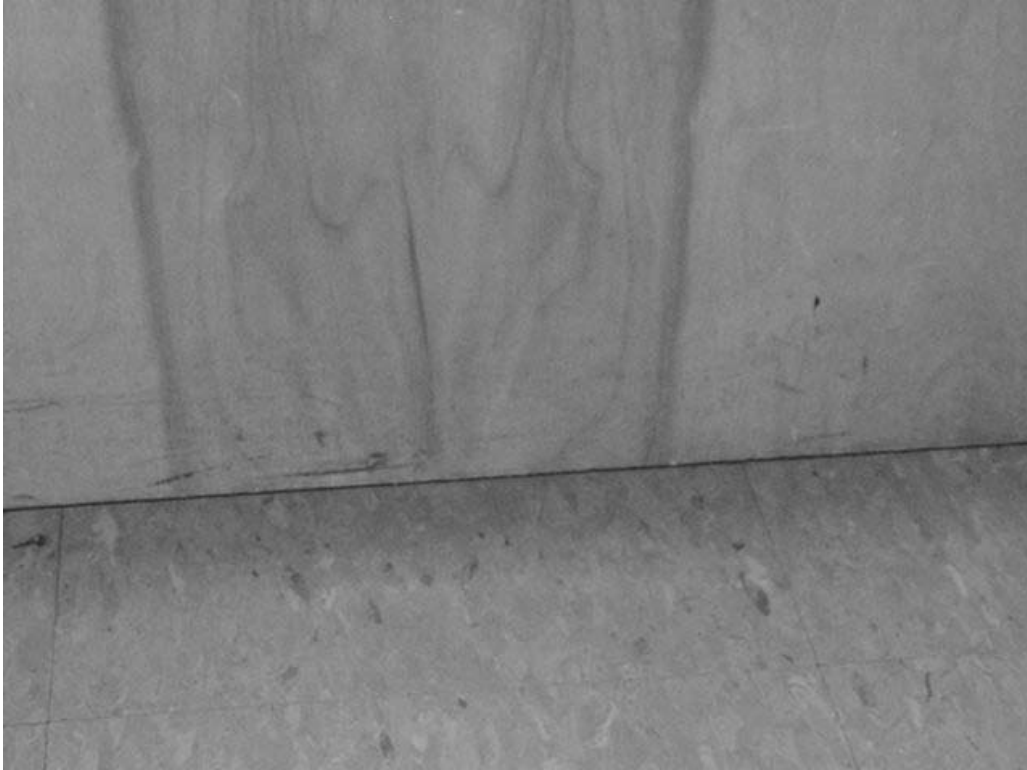
Picture 7

Coat Closet Door, Note Small Undercut at Bottom at Door Limiting Airflow into the Closet

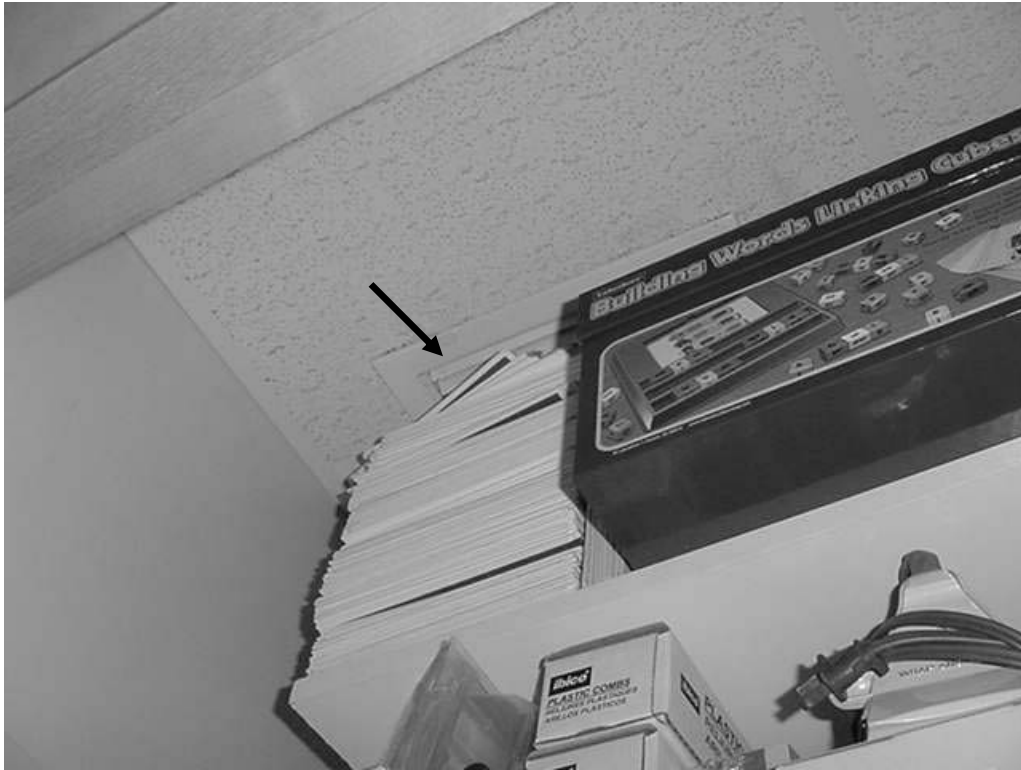
Picture 8

Exhaust Vent Blocked by Various Items

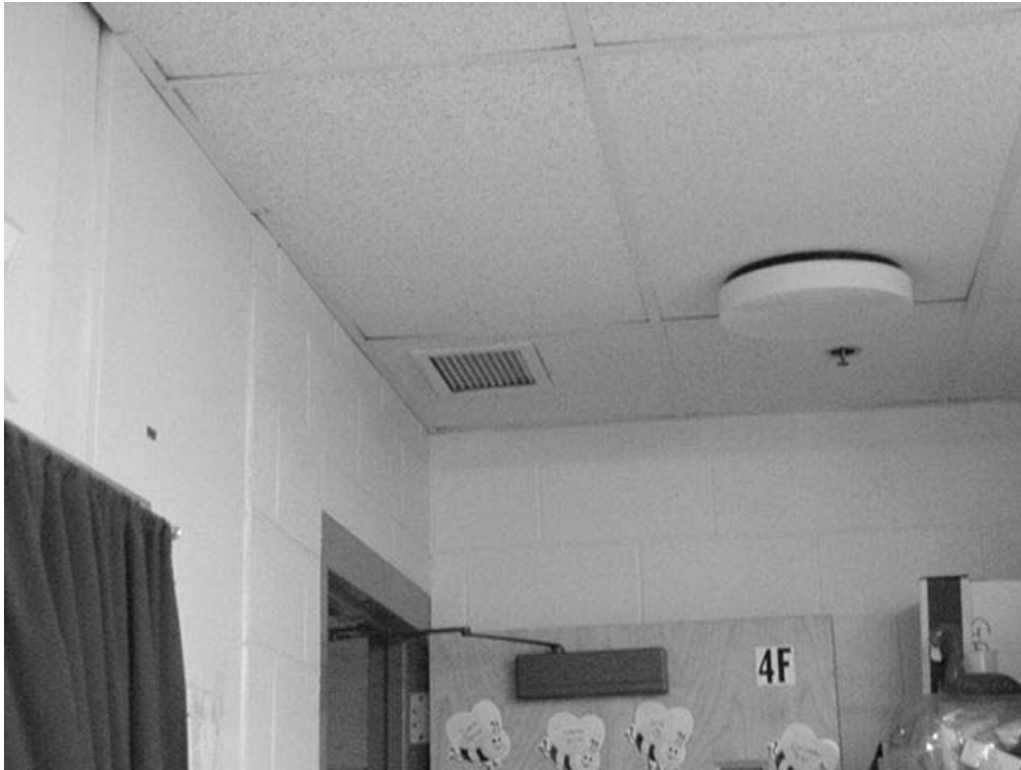
Picture 9

Proximity of Exhaust Vent to Classroom Door

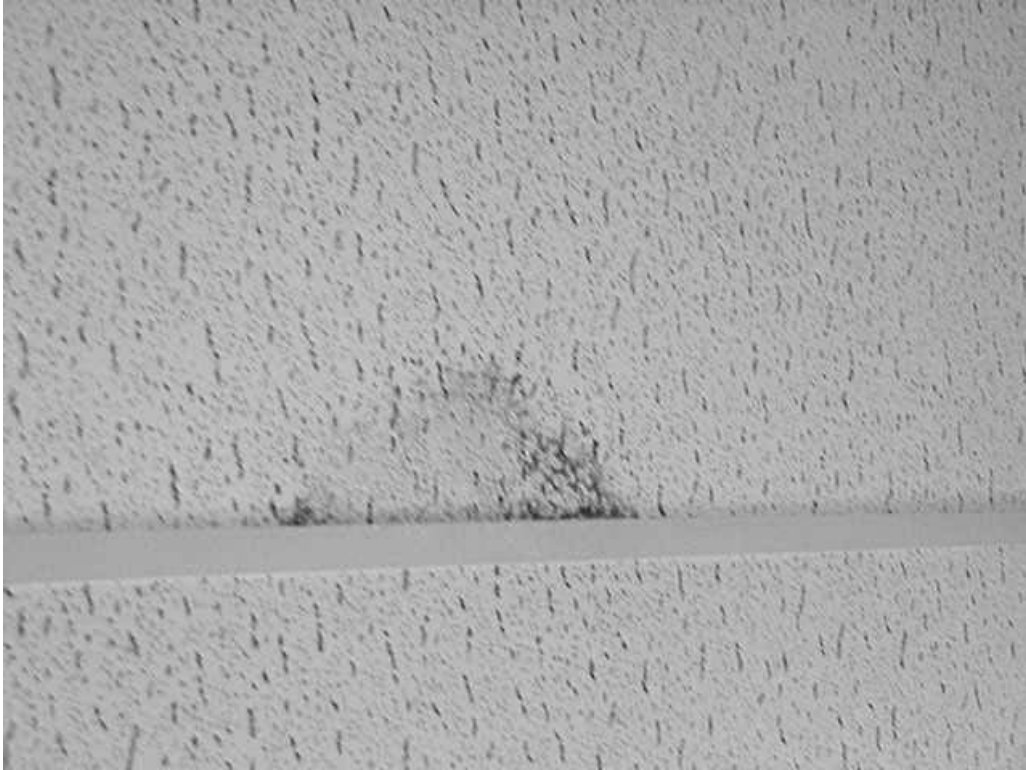
Picture 10

A number of rooms had water-stained ceiling tiles (Picture 10). Water-damaged ceiling tiles can indicate a leak(s) in the roof and/or pipes. Water-damaged ceiling tiles can provide a source of mold growth and should be replaced after a water leak is discovered and repaired. Appropriate measures should also be taken to minimize the aerosolization of particulates from tile removal/replacement.

Water Damaged Ceiling Tile

8. Identify and repair sources of water leaks. Replace water-damaged ceiling tiles. These ceiling tiles can be a source of microbial growth. Examine the non-porous surface

beneath the removed ceiling tiles and disinfect with an appropriate antimicrobial.

Appropriate measures should also be taken to minimize the aerosolization of particulates from tile removal/replacement.

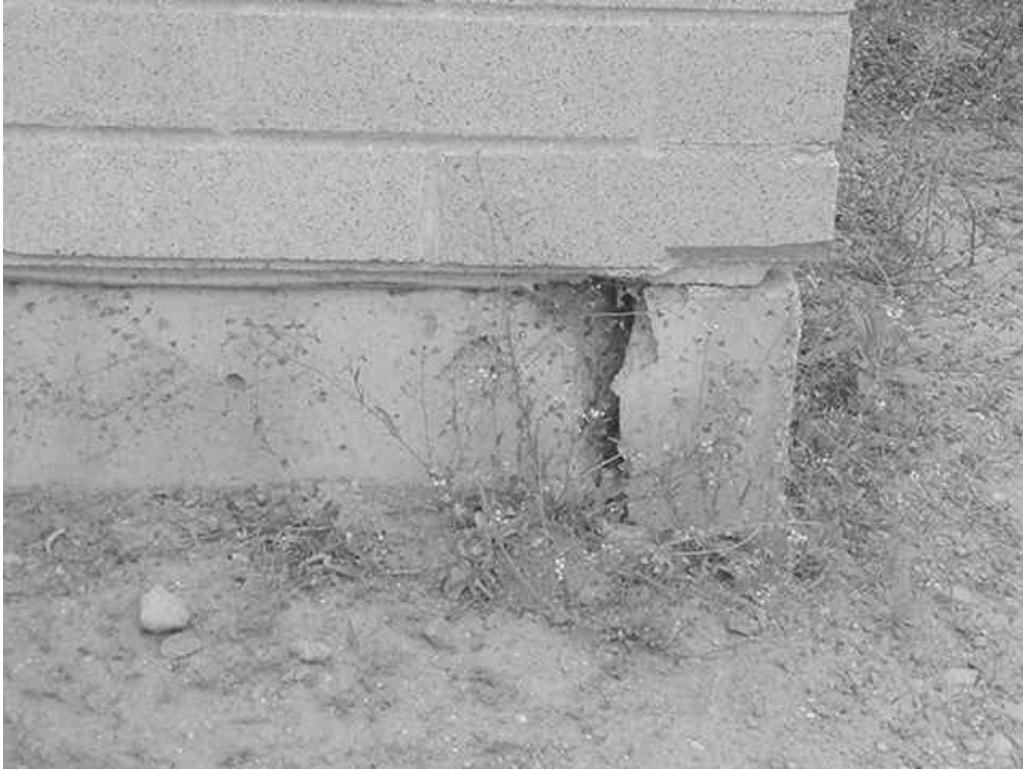
Picture 13

A number of conditions observed along the building exterior may be conducive to water penetration through the building envelope. Missing/damaged mortar around masonry was observed in several areas (Pictures 13 and 14). Holes, breaches, and seams are points through which water can penetrate the building, particularly under driving rain conditions. The gutter/downspout system was damaged/missing in several areas (Picture 15), and the base of the exterior wall appeared to be moistened. Chronic exposure of the exterior brickwork and foundation to water can provide a source for water intrusion and, overtime, result in structural damage. In addition, breaches can serve as points of entry or shelter for pests.

Damaged Foundation

9. Consider repointing building exterior. Seal breaches to the building exterior to prevent pest and water intrusion.
10. Replace missing downspout. Examine gutter/downspout system periodically to ensure gutters are free of debris, and downspouts are intact.

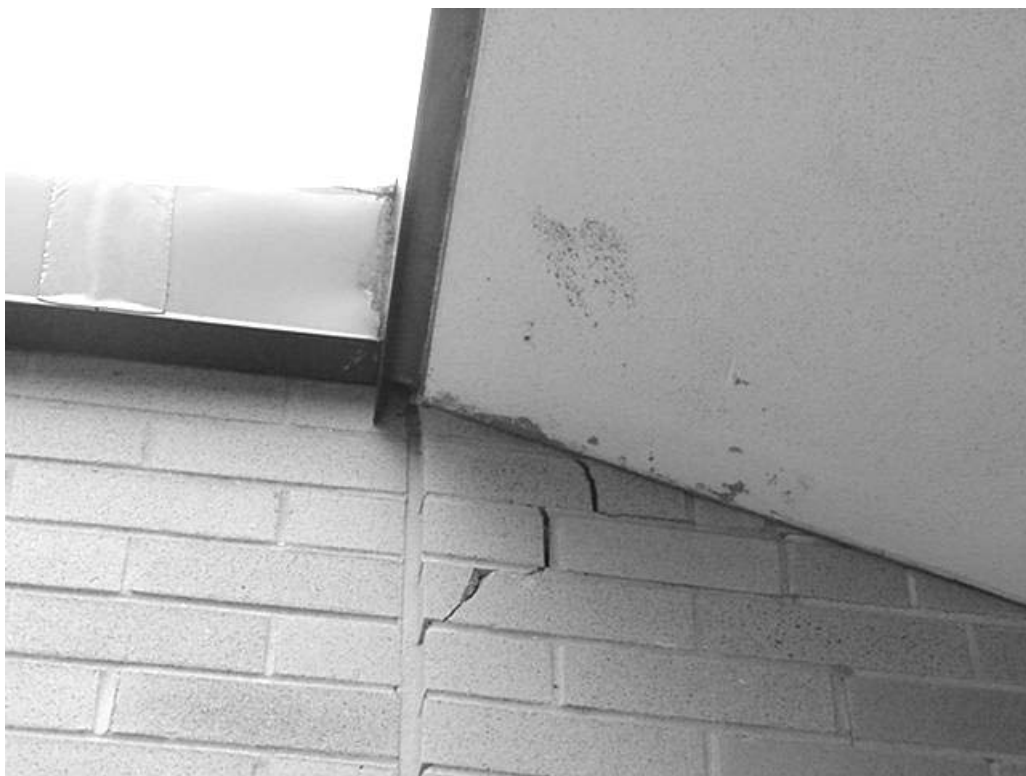
Picture 14

Damaged Brickwork on Exterior Wall

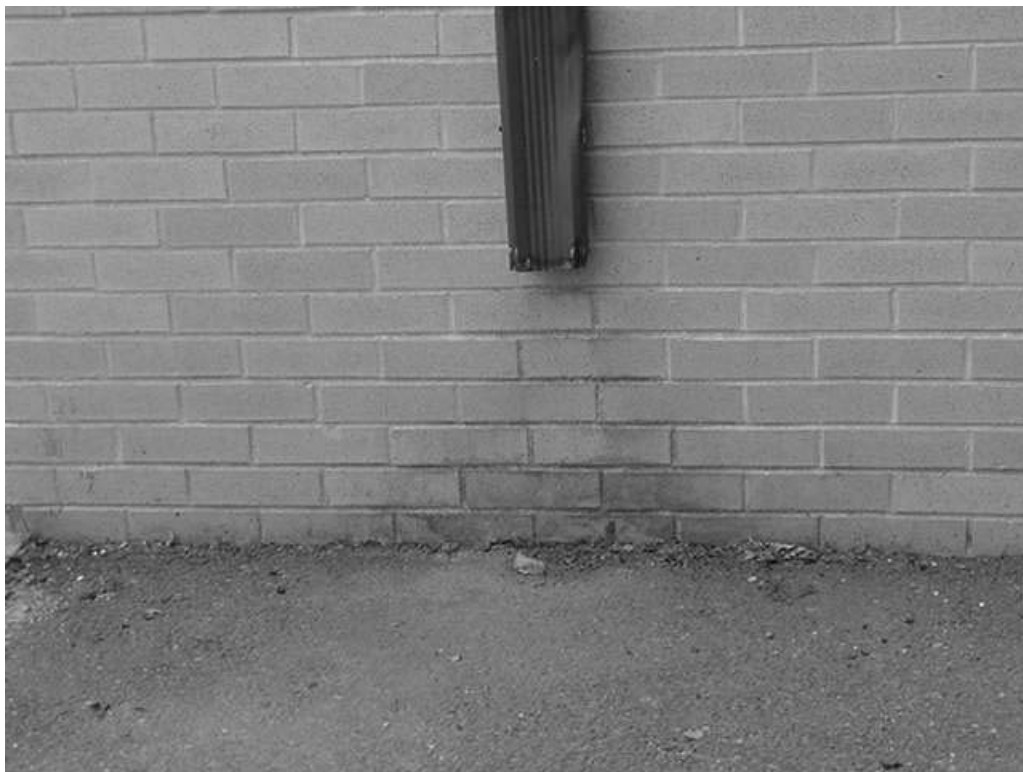
Picture 15

Missing Portion of Downspout/Elbow Extension

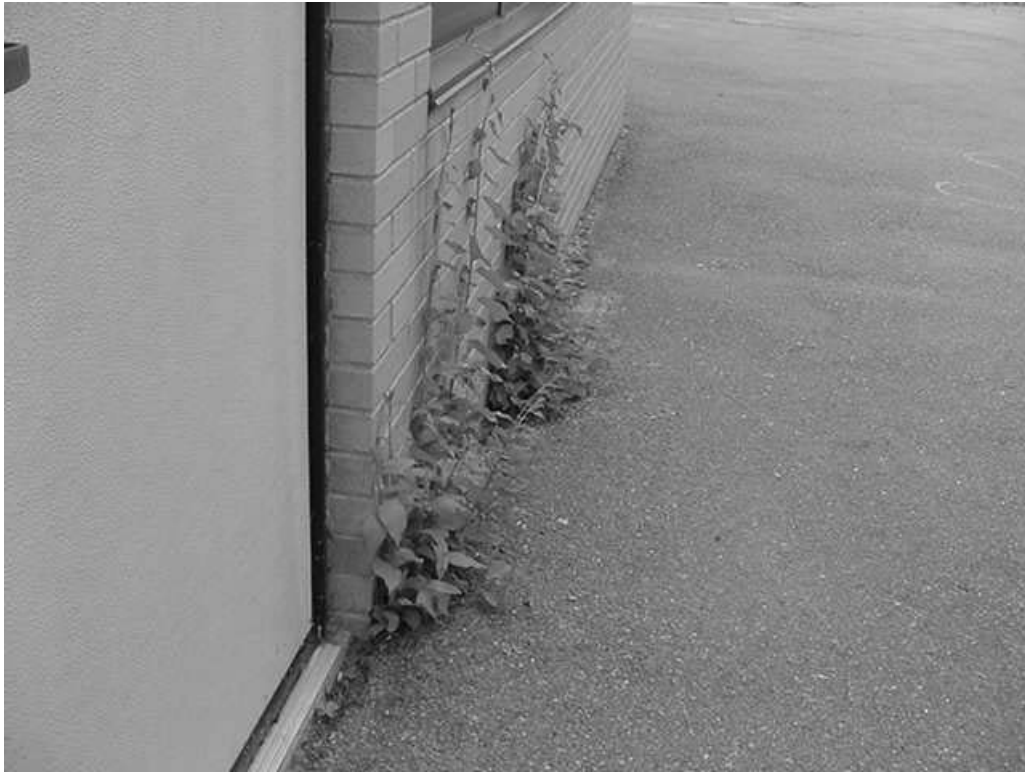
Picture 16

Shrubby and other plants were observed to be growing in cracks and crevices in close proximity to foundation walls (Picture 16). The growth of roots against exterior walls can bring moisture in contact with wall brick and eventually lead to cracks and/or fissures in the foundation below ground level. Over time, this process can undermine the integrity of the building envelope and provide a means of water entry into the building through capillary action through foundation concrete and masonry (Lstiburek & Brennan, 2001).

Plants Growing between Exterior Wall and Tarmac

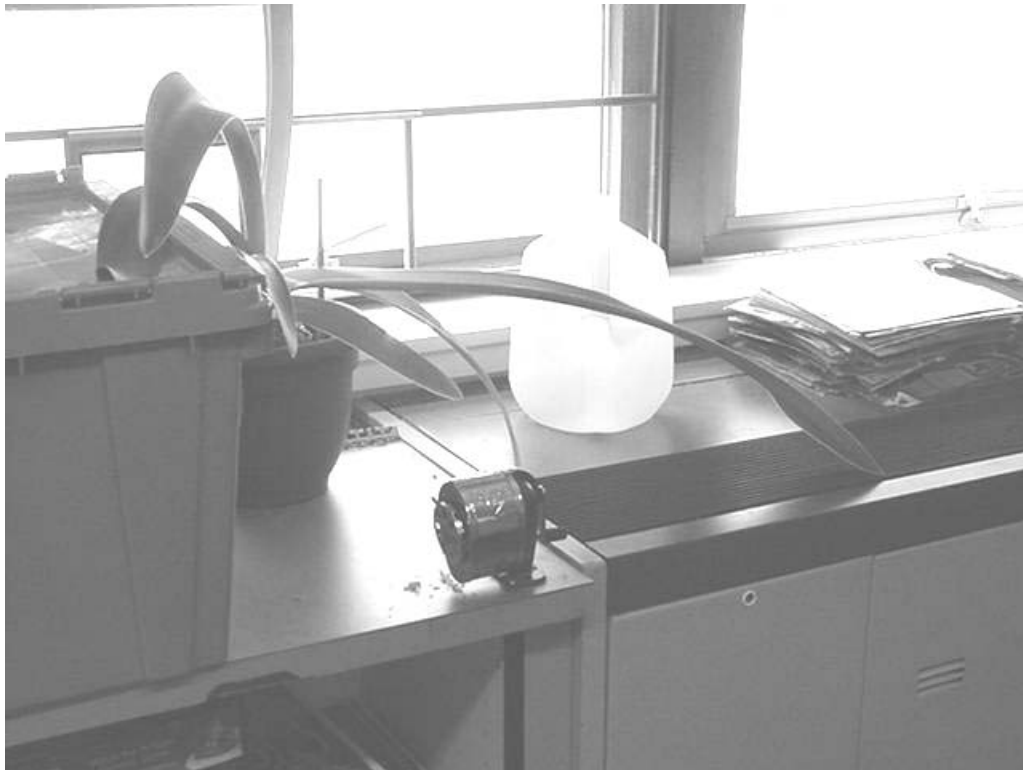
Picture 17

Plants were observed in several classrooms. Plants should be properly maintained and equipped with drip pans. Some plants were placed near ventilation sources (Picture 17). Plants can be a source of pollen and mold, which can be respiratory irritants for some individuals. Plants should not be placed directly on carpeting and should be located away from univent air diffusers to prevent the aerosolization of dirt, pollen or mold. In one classroom, a garden with wood chips and plants was placed on a carpeted area (Picture 18). It is unclear whether the basin holding the wood chips and plants is lined with plastic. If unlined and/or the basin were to leak,

Plant and Pencil Sharpener Near Univent Air Diffuser

13. Examine plants in classrooms for mold growth in water catch basins. Disinfect water catch basins if necessary. Remove plants from ventilation sources and carpeted areas.

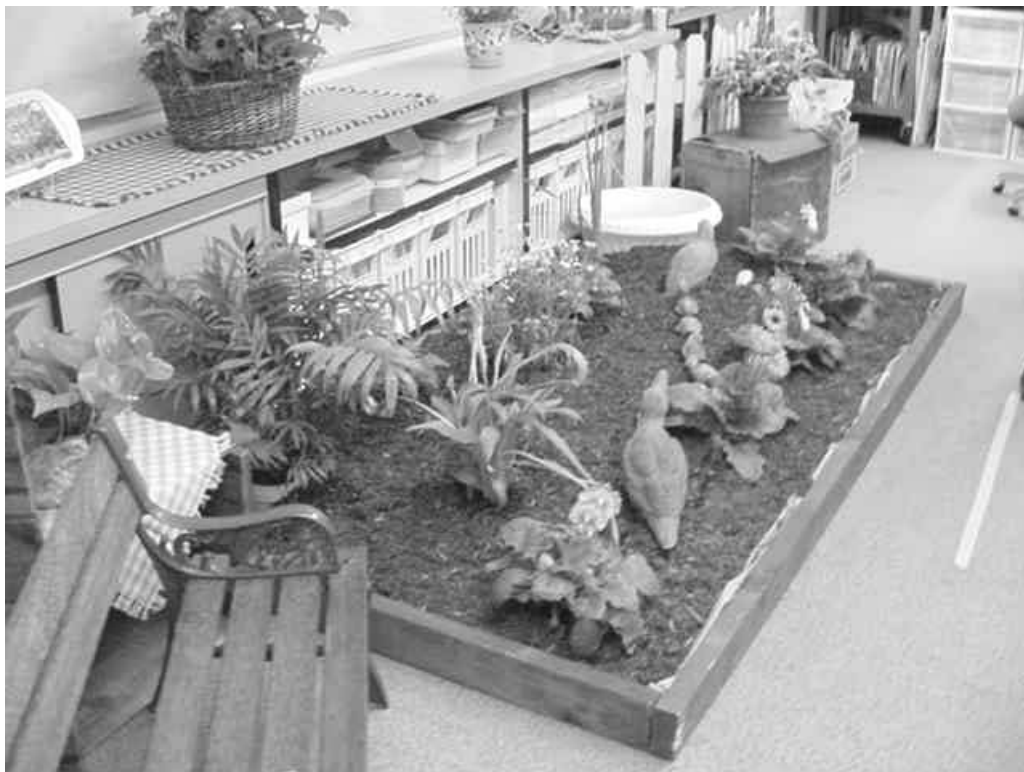
Picture 18

water could damage the carpeting below. The potential for mold growth exists if the carpeting remained moist and the damage were undiscovered. In addition, since wood chips retain moisture, they can be a source for odors and mold growth.

Indoor Garden on Carpet in Classroom

14. Consider removing classroom garden to prevent odors and potential mold growth.
15. Clean and maintain aquariums and terrariums to prevent bacterial/microbial growth and associated odors.

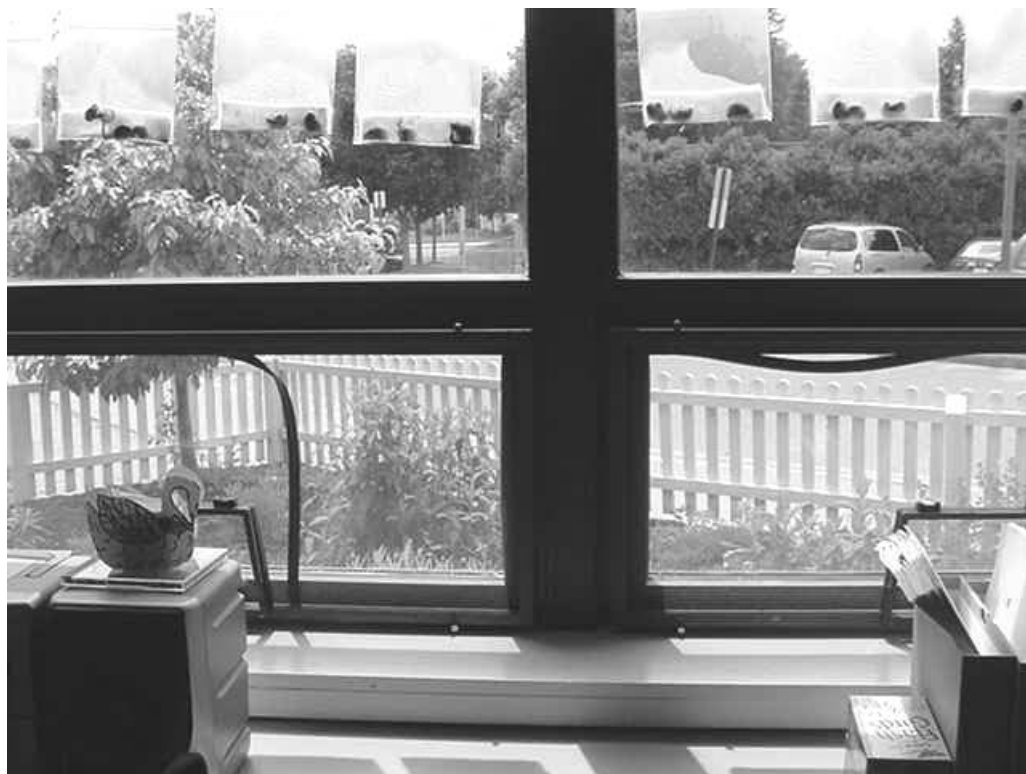
Picture 19

A rubber gasket for a classroom window was also failing (Picture 19). These breaches can serve as points for water entry and/or drafts into the building. Continued freezing and thawing of water during cooler months will serve only to cause further damage.

Failing Rubber Window Gaskets in Classroom

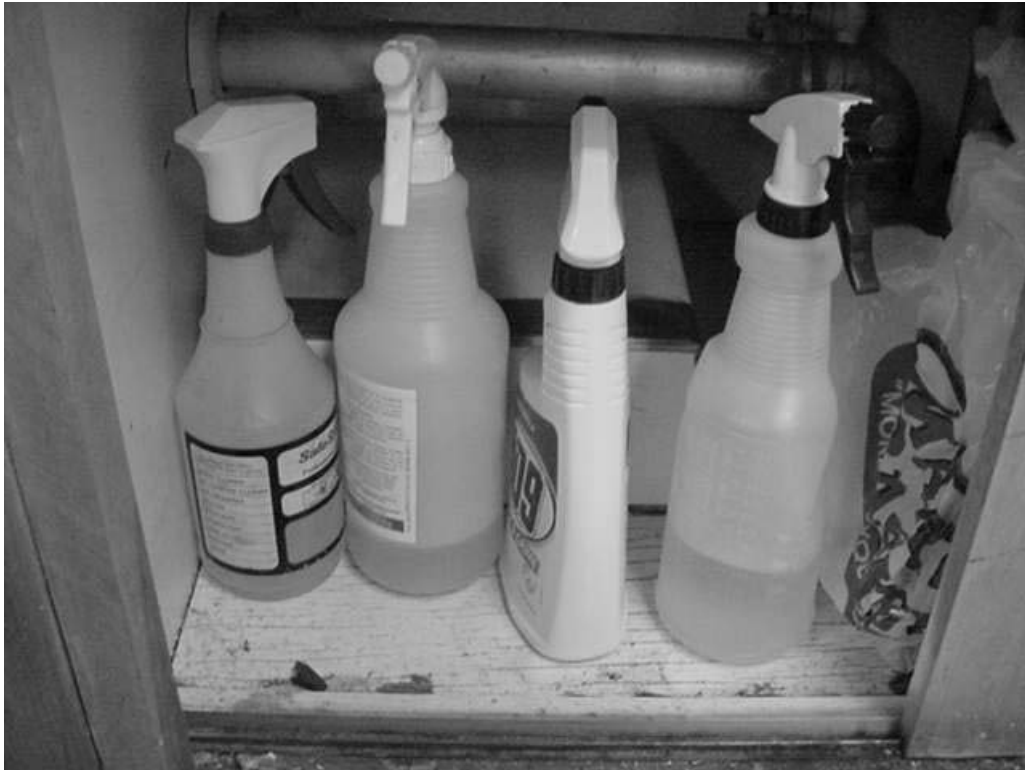
Picture 20

Cleaning products were found on countertops and in unlocked cabinets beneath sinks in some classrooms (Picture 20). Like dry erase materials, cleaning products contain VOCs and other chemicals that can be irritating to the eyes, nose and throat of sensitive individuals. In addition, plug-in air fresheners/deodorizers were in use in some classrooms. These products

Spray Bottles of Cleaning Products in Unlocked Classroom Sink Cabinet

16. Clean chalkboards and dry erase board trays regularly to avoid the build-up of particulates.
17. Store cleaning products properly and out of reach of students. Ensure spray bottles are properly labeled.

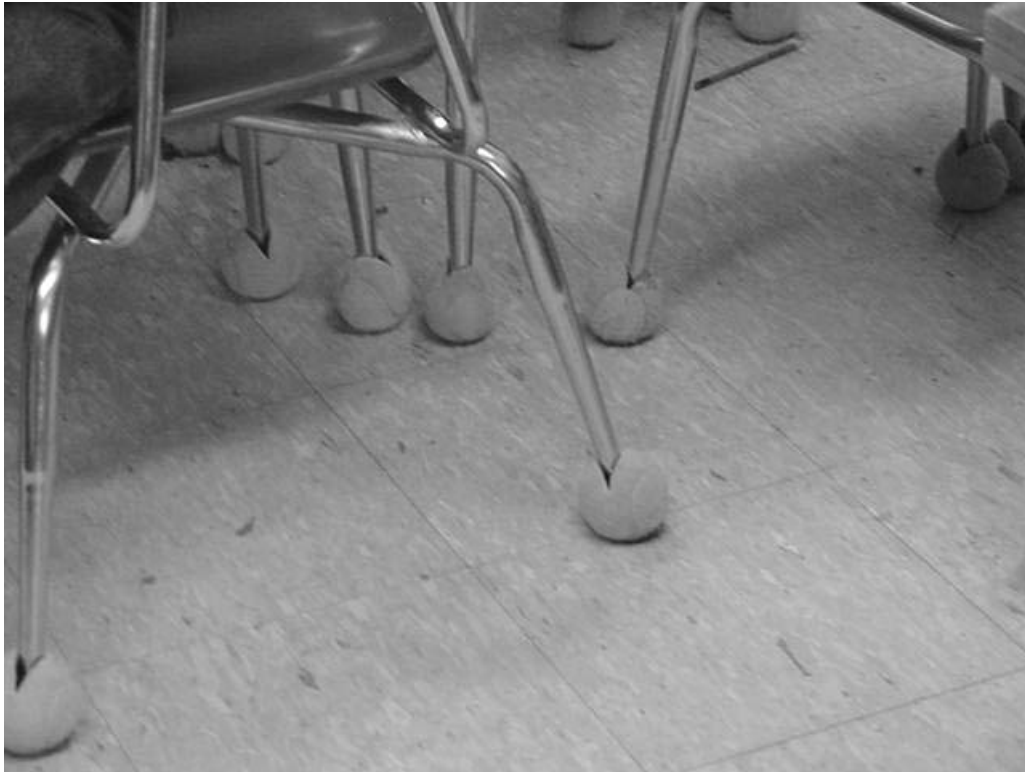
Picture 21

In an effort to reduce noise from sliding chairs, tennis balls had been sliced open and placed on chair legs (Picture 21). Tennis balls are made of a number of materials that are a source of respiratory irritants. Constant wearing of tennis balls can produce fibers and off-gas VOCs. Tennis balls are made with a natural rubber latex bladder, which becomes abraded when used as a chair leg pad. Use of tennis balls in this manner may introduce latex dust into the school environment. Some individuals are highly allergic to latex (e.g. spina bifida patients) (SBAA, 2001). It is recommended that the use of materials containing latex be limited in buildings to reduce the likelihood of symptoms in sensitive individuals (NIOSH, 1997). A question and answer sheet concerning latex allergy is attached as Appendix B (NIOSH, 1998). Consider replacing tennis balls with alternative glides (Picture 22).

Tennis Balls on Chair Legs

21. Store nests in resealable bags, away from ventilation sources.
22. Refrain from hanging objects from ceiling tile systems.
23. Consider replacing tennis balls with alternative glides.

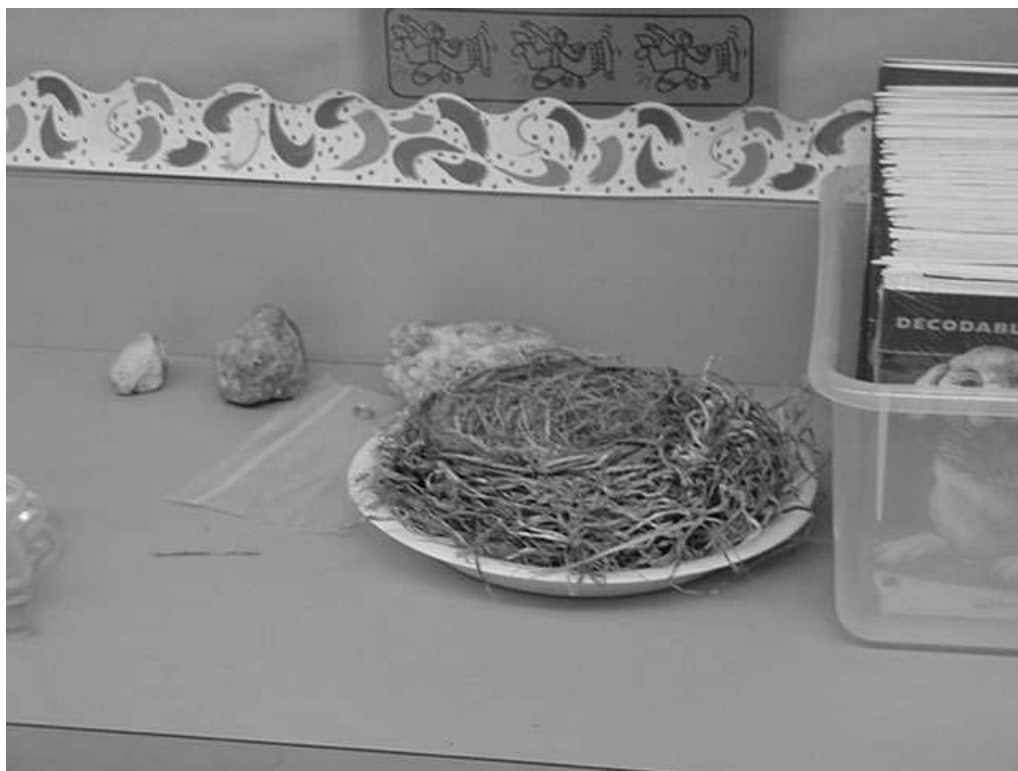
Picture 23

Birds Nest in Classroom

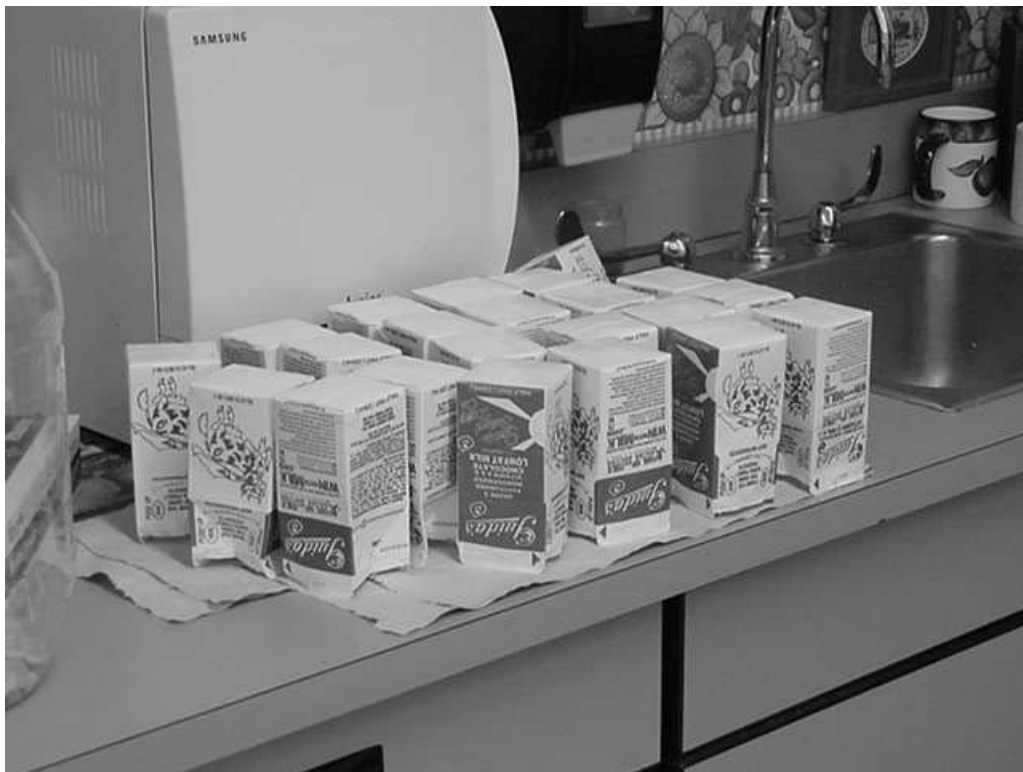
Picture 24

Finally, of note was the observation of re-use of food containers for projects (Pictures 24 and 25). Food is an attractant to pests and rodents. Reuse of food containers (e.g., for art projects) is not recommended since food residue adhering to the container surface may serve to attract pests.

Empty Milk Containers for Projects

24. Refrain from re-using food containers as materials for projects.
25. Consider adopting the US EPA document, *Tools for Schools* (US EPA, 2000b), as a means to maintaining a good indoor air quality environment in the building. This document can be downloaded from the Internet at <http://www.epa.gov/iaq/schools/index.html>.

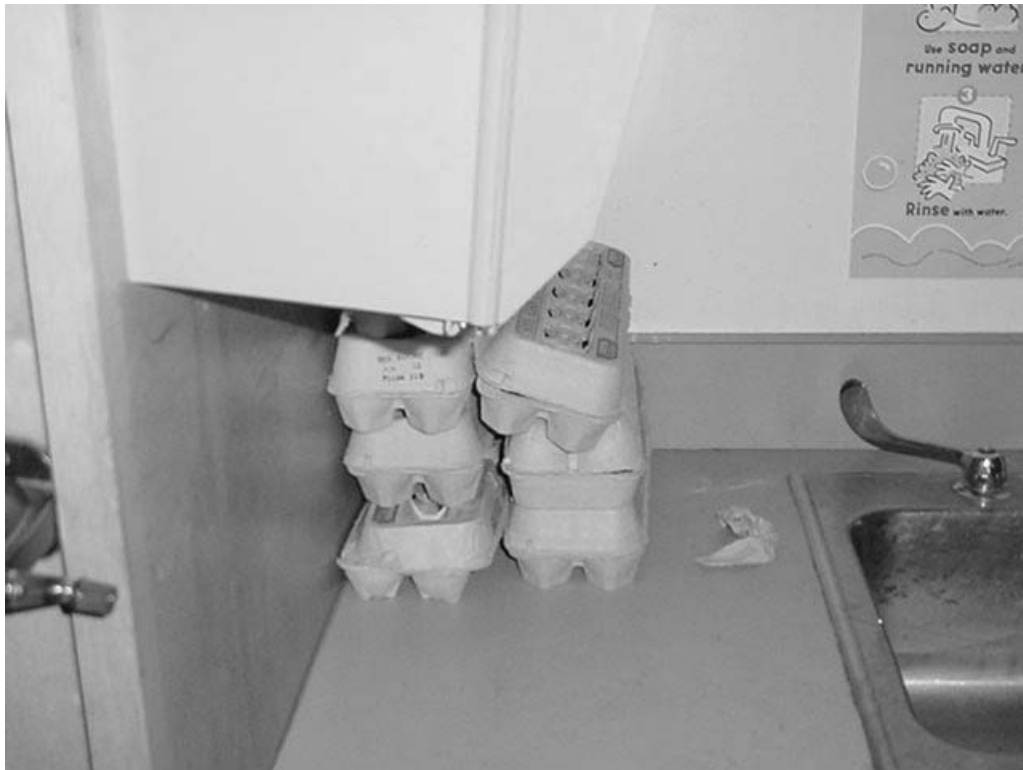
Picture 25

Empty Egg Containers for Projects
